To: Renee Lewis, Questor
From: Todd Coffin
Re: Preliminary Report on Test Results at 7 Depot Street, January 13, 2004
Date: February 3, 2004.

To: Renee Lewis, Questor
From: Todd Coffin, Jacques Whitford Company, Inc.
Subject: Preliminary Results for Supplemental PCB Testing
Date: December 17, 2003

ASBESTOS SURVEY REPORT

**Former Industrial Building
7 Depot Street
Windham, Maine**

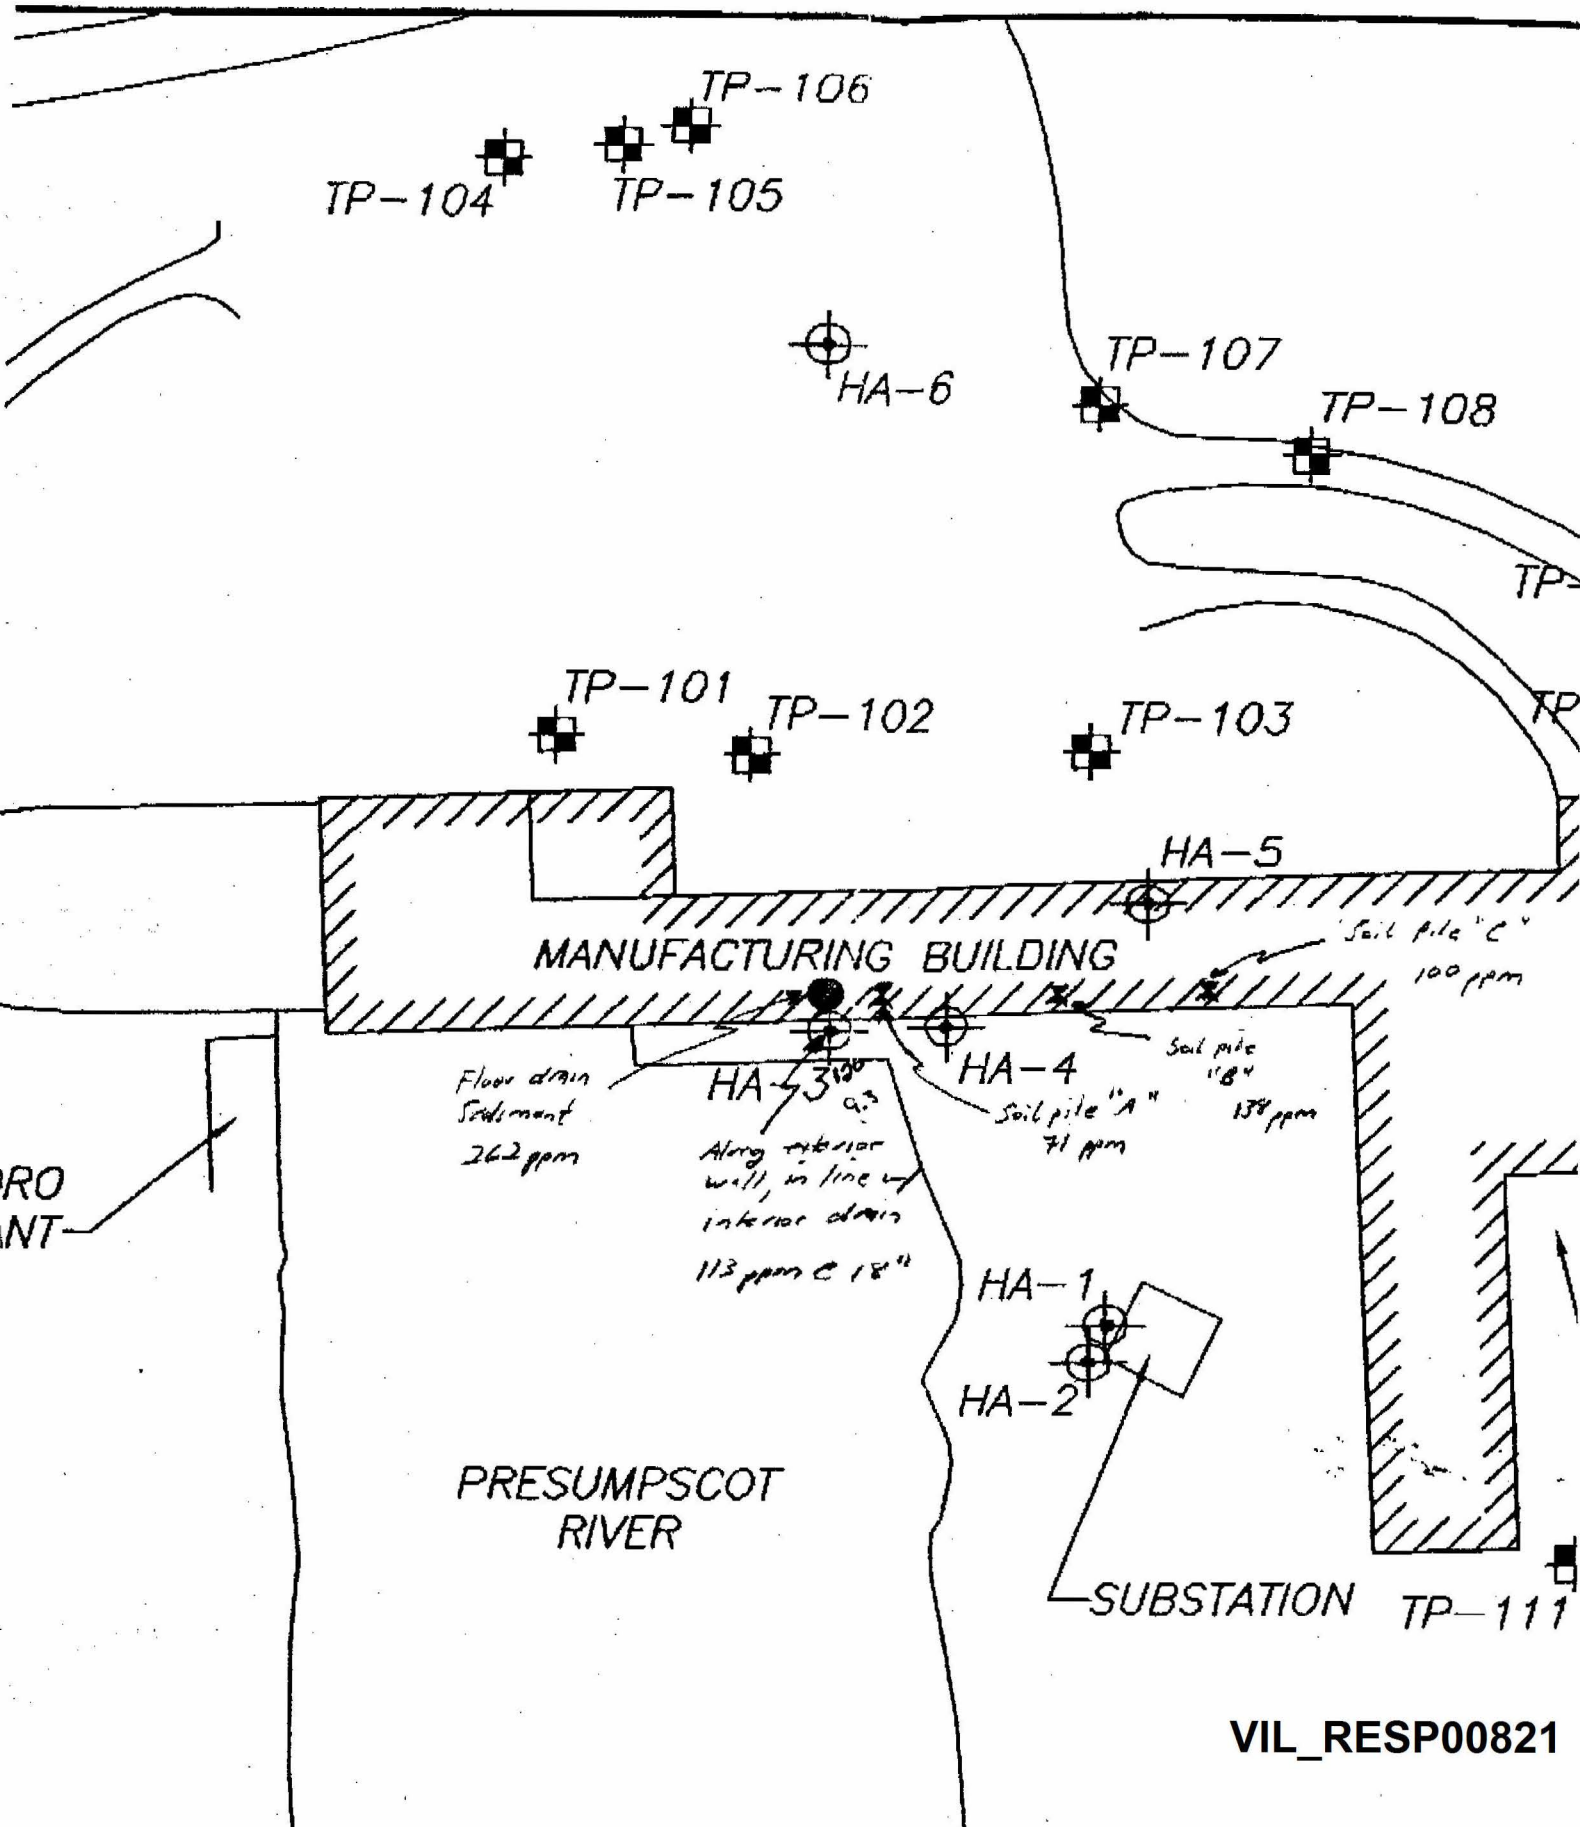
A PCB concentration of 173 ppm was detected in sediment sampled from the drain on November 25, 2003. Because of the potential for the drain to discharge to the outside subsurface environment, follow-up sampling was conducted on January 13, 2004. Results of the November sampling event, which included a number of other surface sample locations inside and outside the building, were presented to you in a memorandum dated December 17, 2003.

The attached figure shows the locations of the samples and PCB concentrations. The concentrations ranged from 71 ppm (soil pile "A") to 262 ppm (floor drain sediment), well above the 1 ppm human-health based clean-up guideline under the Toxic Substances Control Act (TSCA). We detected 113 ppm PCBs in the shallow subsurface soils collected outside the building (1.5-foot depth), in line with the floor drain. The exterior sample was collected at a depth at, or slightly below, the water table. A slight sheen was observed on the soils sampled, and on the water table.
